## Colusa Unified School District

## **Bright Schools Program – Scoping Audit**

Site(s):	Burchfield Primary School - 400 Fremont Street, Colusa CA 95932 Egling Middle School - 813 Webster Street, Colusa CA 95932 Colusa High School - 901 Colus Avenue, Colusa CA 95932
Date:	May 15, 2014
District Contact:	Jim LaGrone, MOT Director (530) 458-7791, jlagrone@colusa.k12.ca.us
CEC Contact:	<b>Jim Holland</b> , Project Manager (916) 651-9857, Jim.Holland@energy.ca.gov

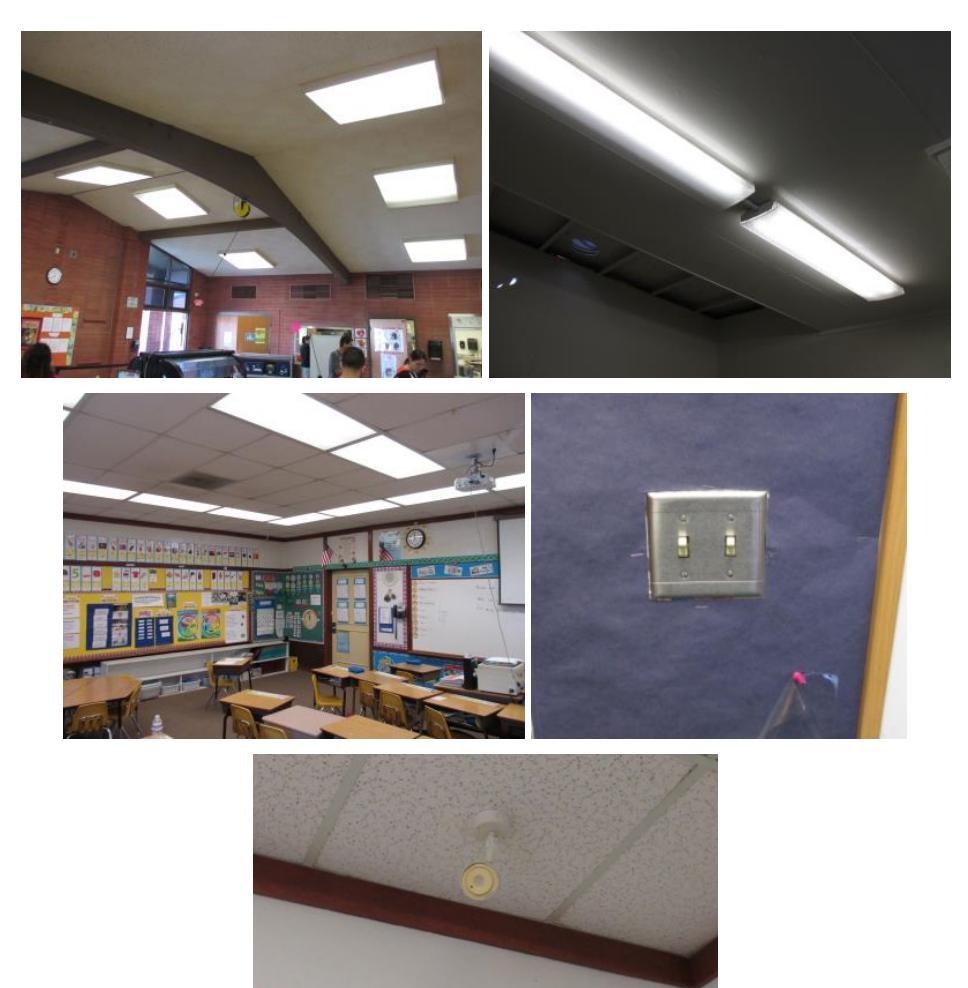
The classroom lighting is primarily recessed fluorescent T8 troffer fixtures with prismatic lenses. Hallway lighting consists of ceiling mounted T8 fixtures with prismatic wrap lenses. There are also 4'x4' box framed fixtures with T8 lamps in the cafeteria. The fixtures throughout the school are mainly controlled with manual switches, with the exception of permanent classrooms 12 through 15, which also have daylight sensors to turn off lighting in the classrooms. Lamps are 32 watts and typically 4100 kelvin.

Figure 2: Cafeteria (Top Left), Hallway (Top Right) and Classroom T8 Fixtures (Middle Left), Typical Light Switches (Middle Right) and Daylight Sensor (Bottom)

Priority	No.	Measure Name	Site	System/ Equipment	Observation	Recommendation
Medium	1	Install Occupancy Sensors in Classrooms	Burchfield Primary, Egling Middleand Colusa High Schools	Lighting	The lights in the classrooms are controlled using manual switches. The school staff usually turn off lights when spaces are not in use, but occassionally, lights are left on while unoccupied.	Controlling the light fixtures with occupancy sensors will reduce the operating time of the fixtures. Occupancy sensors will ensure that the lights are turned off when the classrooms are unoccupied.
Medium	2	Exterior Lighting	Burchfield Primary School	Exterior Lighting	There is one pole-mounted HID fix ture in the parking lot that illuminates the walkway in front of the school and the flag pole at night.	Replace the HID lights with LED fix tures or induction lamps.
Medium	3	Upgrade Split-System and Heat Pump Units	Burchfield Primary, Egling Middleand Colusa High Schools	Portables	We observed wallpack heat pumps (Bard or equivalent) used to condition the portable classrooms.	Upgrade the heat pumps to Title 24 standards or better. Include economizers on wall pack units.

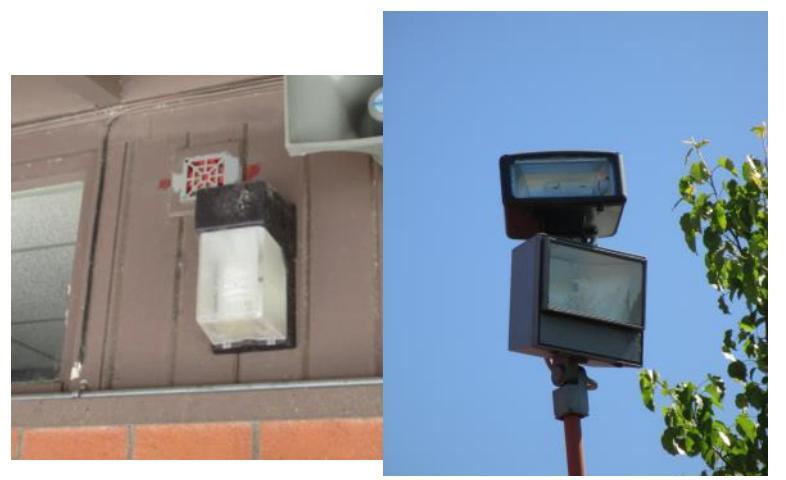
There are wallpacks by the door of each classroom that open up to the outside. The wallpacks each have 26-watt compact fluorescent lamps (CFLs) and integrated photocells. There is also one pole mounted dual head light fixture with high intensity discharge (HID) lamps that is used to illuminate a flag pole and to illuminate the walkway in front of the school office.

Figure 3: CFL Wall Pack with Integrated Photocell (Left), Pole Mounted Exterior HID Fixtures (Right)

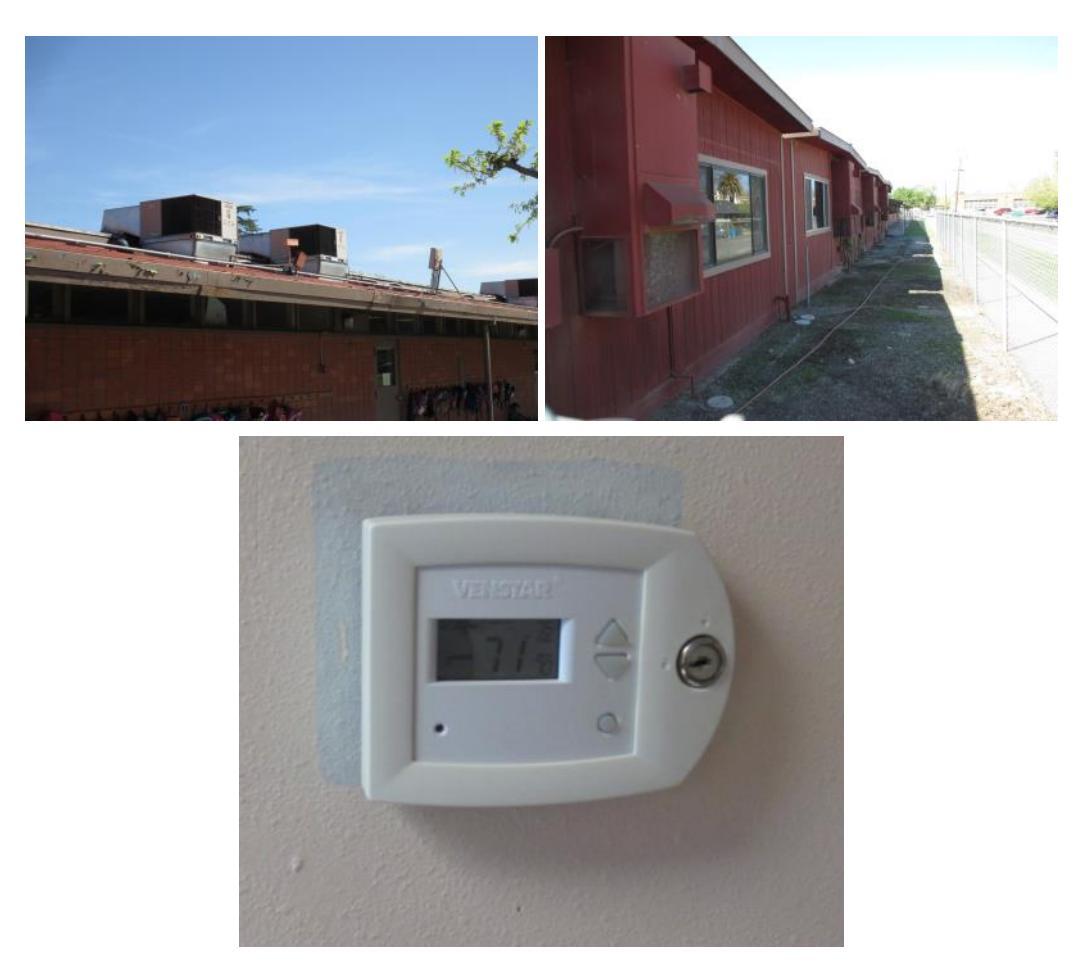
The permanent classrooms use packaged rooftop units (RTUs) and portable classrooms use wall-mounted gas packs. The HVAC equipment is controlled by digital programmable thermostats. It was observed that although the thermostats were locked to prevent tampering with the settings, the thermostat settings were not uniform and date and time settings were also not calibrated. During the scoping audit, we observed that a window was open in one of the permanent classrooms while the air conditioning equipment was running.

Based on an analysis of the annual energy use, there is significant energy use during the summer, even though school is not in session. This suggests that HVAC equipment is running during the summer. The school district is considering installing wireless thermostats throughout the school, which would allow maintenance personnel to monitor and control the thermostats and turn off equipment from a central and/or remote location.

Figure 4: Permanent Classroom Rooftop Units (Top Left), Portable Classroom Gas Pack Units (Top Right), Digital Thermostat (Bottom)

Medium	4	Replace Rooftop Units with New Efficient Units	Burchfield Primary, Egling Middleand Colusa High Schools	HVAC	The packaged units on these campuses are between 10-30 years old. Most of the package units have economizers, however many of them are non-operational. All of the packaged units we investigated use R-22 refrigerant.	Replace the existing packaged rooftop units (RTUs) with similarly sized high efficiency packaged units that exceed the minimum-efficiency requirements outlined in Title 20 (for units less than 5.5 tons) and Title 24 (all other units). Newly installed packaged units will also provide functioning economizers, to provide maximum free-cooling during moderate conditions and minimizing outside air during temperature extremes.
Medium	5	Wireless-Enabled Thermostats	Burchfield Primary, Egling Middleand Colusa High Schools	HVAC Controls	The thermostats in the classrooms are mostly digital thermostats, but are not programmed with setback schedules. Staff can manually turn on and adjust the temporary setpoint. The district began installing a few wireless network thermostats at Colusa High School.	Install wireless-enabled thermostats which can be controlled and monitored from a remote location by facility maintenance staff. The thermostats can be programmed to operate based on classroom schedules. The thermostats should have a temporary manual override for occasions when classrooms are occupied outside of the regular schedules.

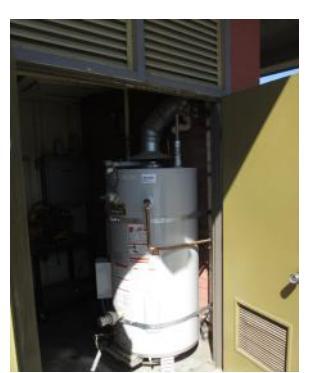
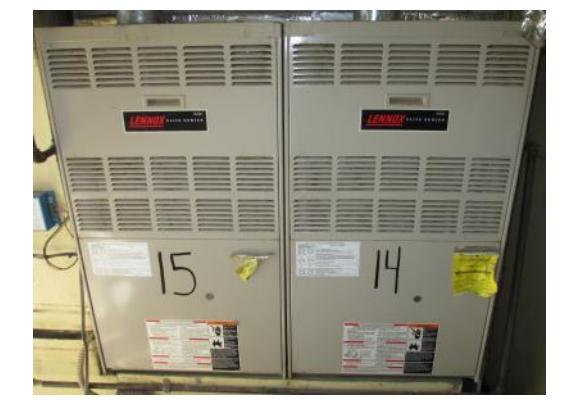
The cafeteria is conditioned with gas furnaces and has an 80% thermal efficiency water heater for domestic hot water.

Figure 5: Domestic Hot Water Heater (Left), Gas Furnaces (Right)

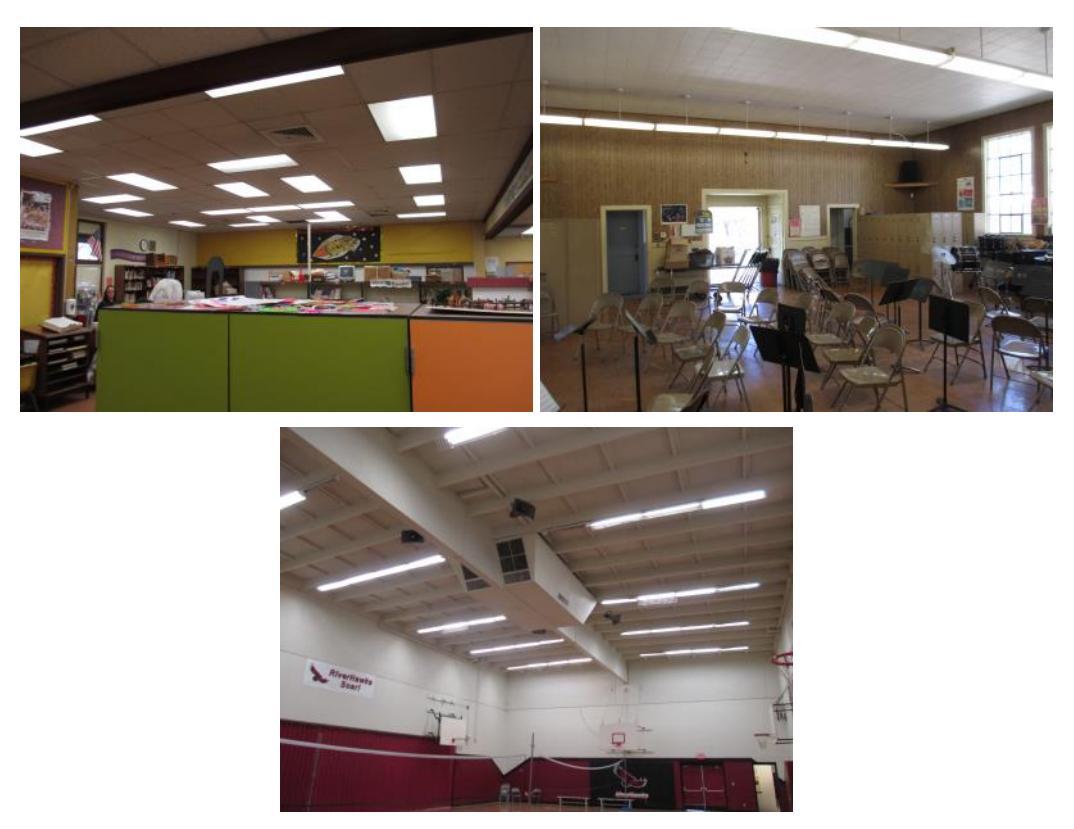
The lighting throughout is primarily recessed fluorescent troffer fixtures. The music room has suspended downlight fixtures with prismatic wrap lenses. The gymnasium has ceiling mounted strip fixtures. Each of these fixtures contain two fluorescent 4-foot T8 lamps. The fixtures are controlled with manual controls. Lamps are 32 watts and typically 4100 kelvin.

Figure 7: Recessed Troffer (Top Left), Suspended (Top Right) and Ceiling Mounted T8 Fixtures (Bottom)

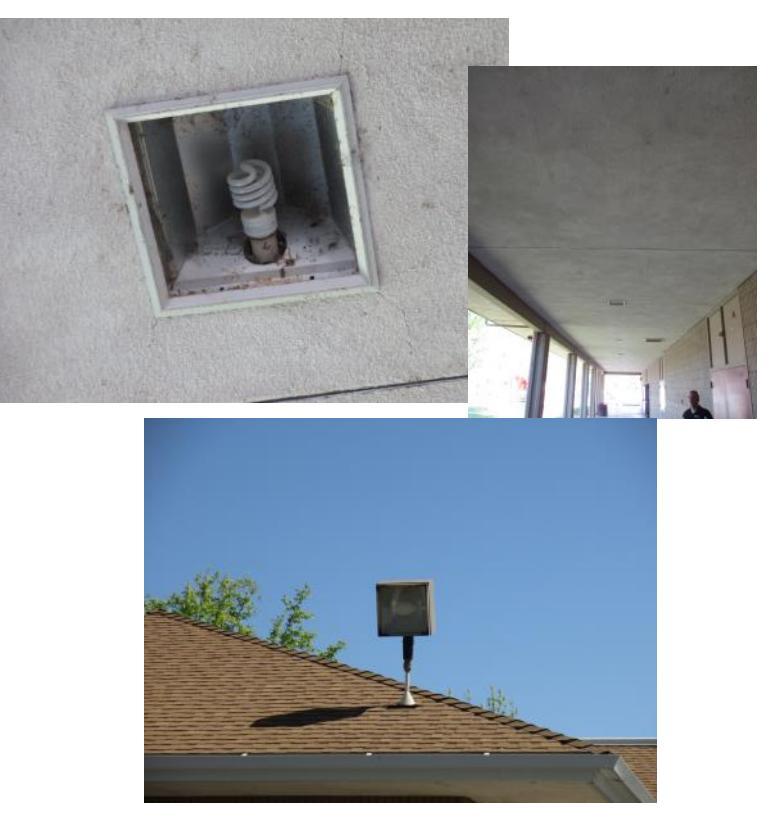
The walkway downlight fixtures each have a 13-watt screw-in compact fluorescent lamp (CFL). There is also a pole-mounted 400-watt high pressure sodium (HPS) fixture that illuminates the basketball courts at night; this also serves as a security light. The exterior fixtures are controlled by photocell.

Figure 8: 13-Watt Walkway Fixtures (Top), HPS Fixture (Bottom)

Medium	6	Solar PV	Burchfield Primary, Egling Middleand Colusa High Schools	Generation	The schools have open solar access in parking lots and many exposed roof surfaces.	Perform a solar PV feasibility study to look at installation at any of the campuses.
Medium	7	Replace Exterior HPS Fixtures with Bi-Level, LED Fxitures	Egling Middle School and Colusa High School	Exterior Lighting	The parking lot and walkways security lights use high pressure sodium lamps. The security lights are controlled by photocells.	Replace the high pressure light fixtures with bi-level LED fixtures equipped with motion sensors mounted at the flood height. The bi-level switching will allow the luminaires to reduce light output(and power consumption) when no motion has been detected for a specified period of time (often 5 minutes).
Medium	8	Replace Restrioom Lighting with Daylighting Fixtures	Colusa High School	Lighting Controls	The boys and girls restroom with skylights provide ample ambient light to illuminate the space.	Install new fixtures with integrated photocells and dimming ballasts.

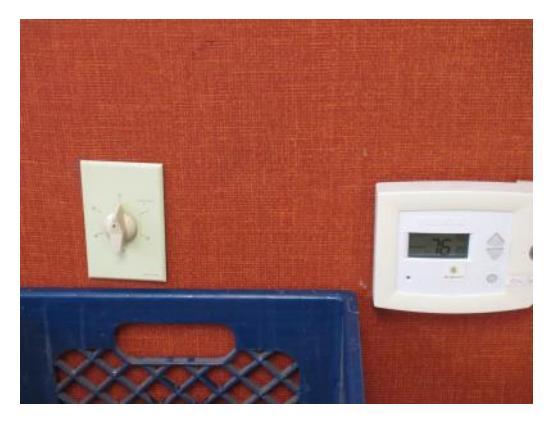
The portable classrooms have either gas packs or heat pumps and are controlled by digital thermostats. The digital thermostats are set up with temperature setbacks of 55°F for heating and 85°F for cooling every day. The thermostats are locked to prevent schedule changes, but staff has access to change the temperature setpoint. The operation of the gas packs and heat pumps are limited by one-hour twist timers.

Figure 9: Digital Thermostat with One-Hour Twist Timer Control

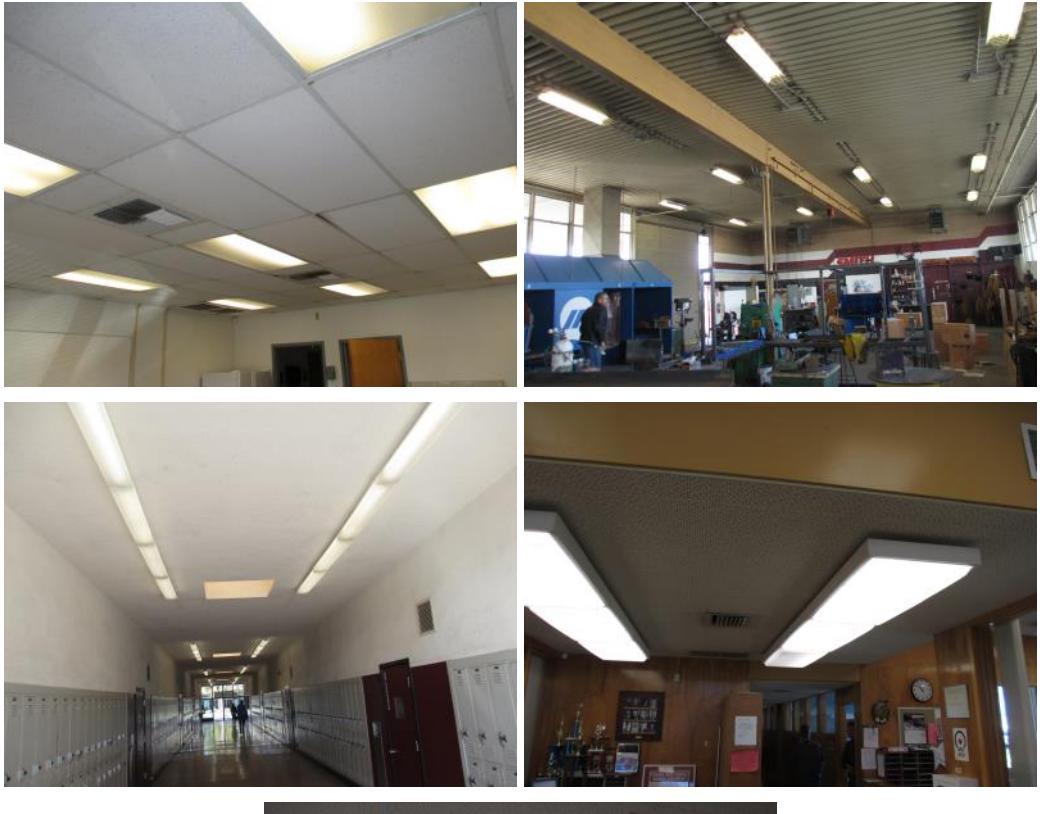
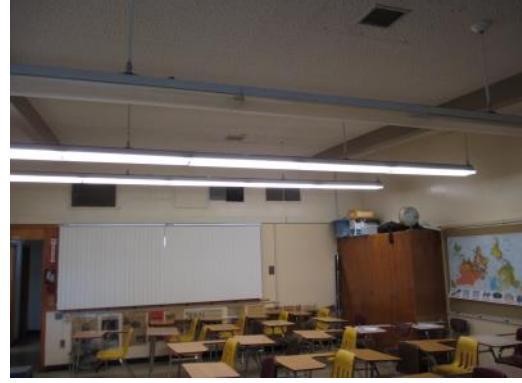
All interior light fixtures are controlled with manual switches.

The lighting consists of recessed troffer, suspended and ceiling mounted fixtures that contain fluorescent T8 lamps. Each T8 fixture contains two fluorescent 4-foot T8 lamps. Lamps are 32 watts and typically 4100 kelvin. The school began replacing the 32 watt lamps with 28 watt lamps, but the maintenance director estimates that only 1% of the fixtures have been retrofitted with the energy-saving T8 lamps.

Figure 11: Sample T8 Fixture Types

Medium	9	Separate Supply Air Register from Return Air Register	Colusa High School	Dist. System	The supply and return air registers are close to each other. This may cause some of the supply air to directly flow into the return air register, or short circuit the air flow. This results in reduced effectiveness of the supply air and causes longer cycling times because it takes a longer time for the space to reach the desired temperature.	Add ductwork to separate the supply air register from the return air register.
Low	10	Replace 32-watt T8 Lamps with 28-watt T8 Lamps	Burchfield Primary, Egling Middleand Colusa High Schools	Lighting Interior	The lights in the classrooms use 32-watt, 4100 kelvin T8 lamps with electronic ballasts. The district is considering replacing the lamps with energy-saving 28-watt T8 lamps and premium efficiency ballasts.	Replace the existing 32-watt T8 lamps with latest-generation 28 watt F28T8 lamps. The new 28W lamps should be installed when most existing lamps are due for replacement. Ballast manufacturers should be contacted prior to installing 28 watt lamps to ensure that the ballast is compatible with the 28 watt lamp.

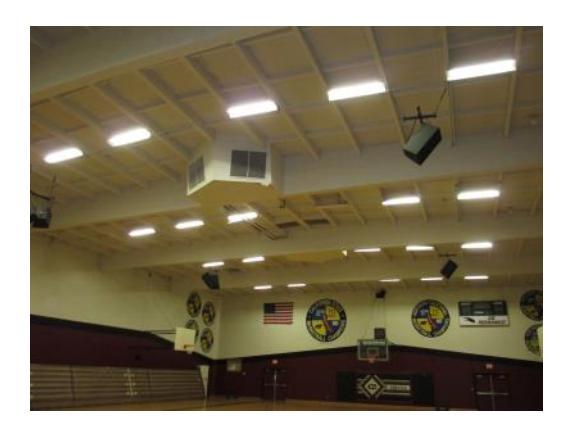
The gymnasium uses high bay ceiling mounted T5 fixtures.

Figure 12: Gym Fixtures

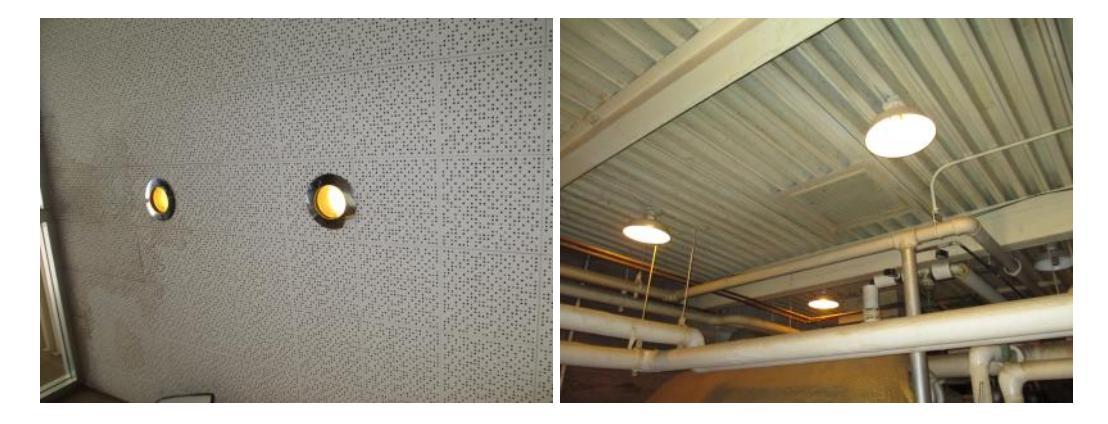
The school also uses compact fluorescent lamps in circular recessed fixtures in the administrative office and pendant lamps in the boiler room.

Figure 13. Recessed Circular Can Fixtures (Left), Pendant Fixtures (Right)

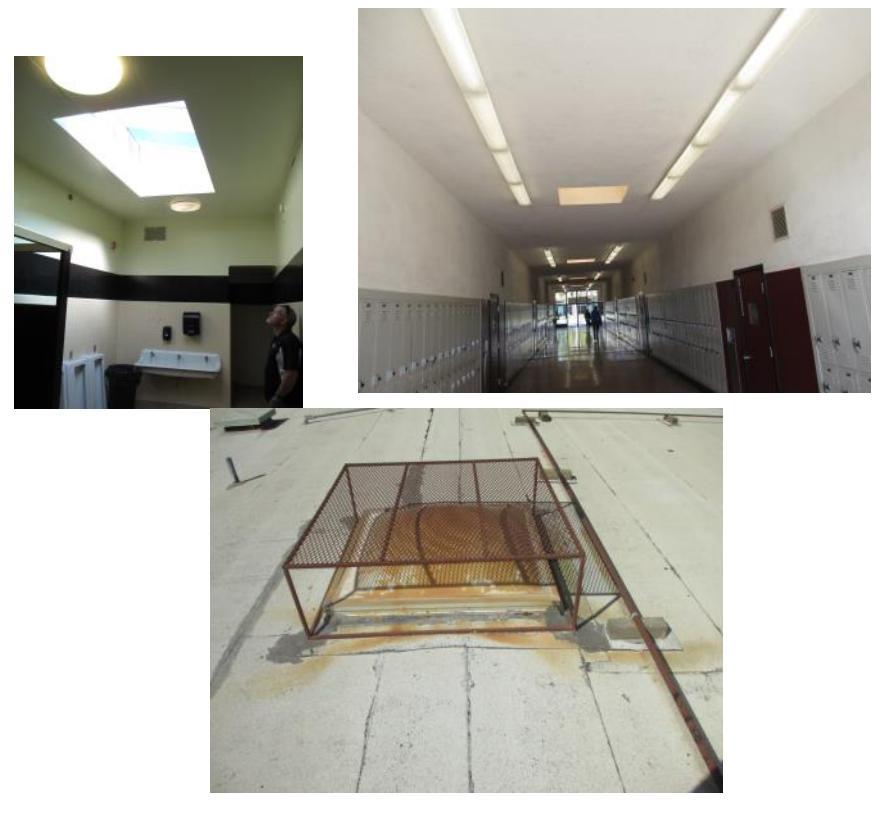
The permanent building that contains Rooms 500 through 508 has boys and girls restrooms with CFL-based circular fixtures. The restrooms have large skylights which provide ample daylighting to the space. The light fixtures in the restrooms are manually controlled and are left on during the day. There are also skylights that illuminate the main hallway through this building, but the skylights are covered with rust due to a metal security gate that was installed to prevent vandalism. The rust on the skylights reduces the amount of daylight through the light wells and also produces a brown-colored light. The maintenance manager said that the metal gates could be removed because all roof access has been secured since the installation of the metal gates.

Figure 14. Skylight in Boys Restroom with Lights On (Top Left), Hallway with Brown-Colored Light through Skylight (Top Right), Metal Security Gate over Skylight (Bottom)

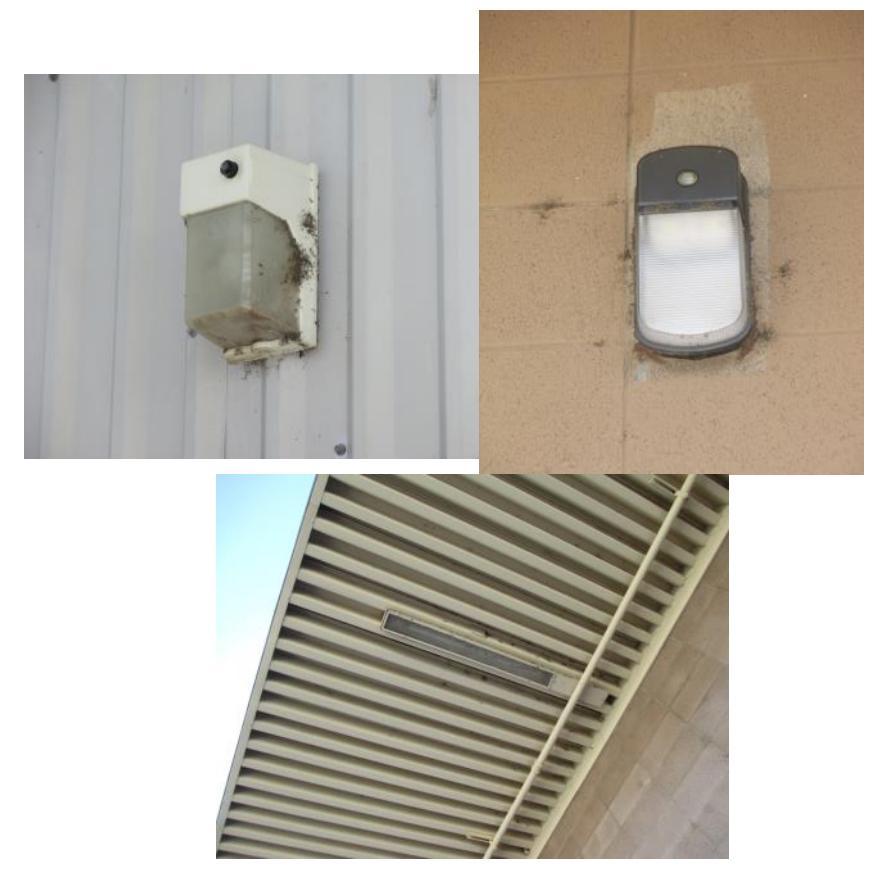
There are approximately 80 wallpacks with integrated photocells around the perimeter of the school. The wallpacks are being upgraded from CFL to LED-based wallpacks. Approximately 30 wallpacks have been replaced with LED wallpacks to date. The CFL-based wallpacks use 13-watt screw-in lamps. There are also 1-lamp T8 fixtures under the awnings by some classrooms.

Figure 15: 13-Watt CFL Wallpack Fixture (Top Left), LED Wallpack Fixture (Top Right), Exterior T8 Fixture (Bottom)

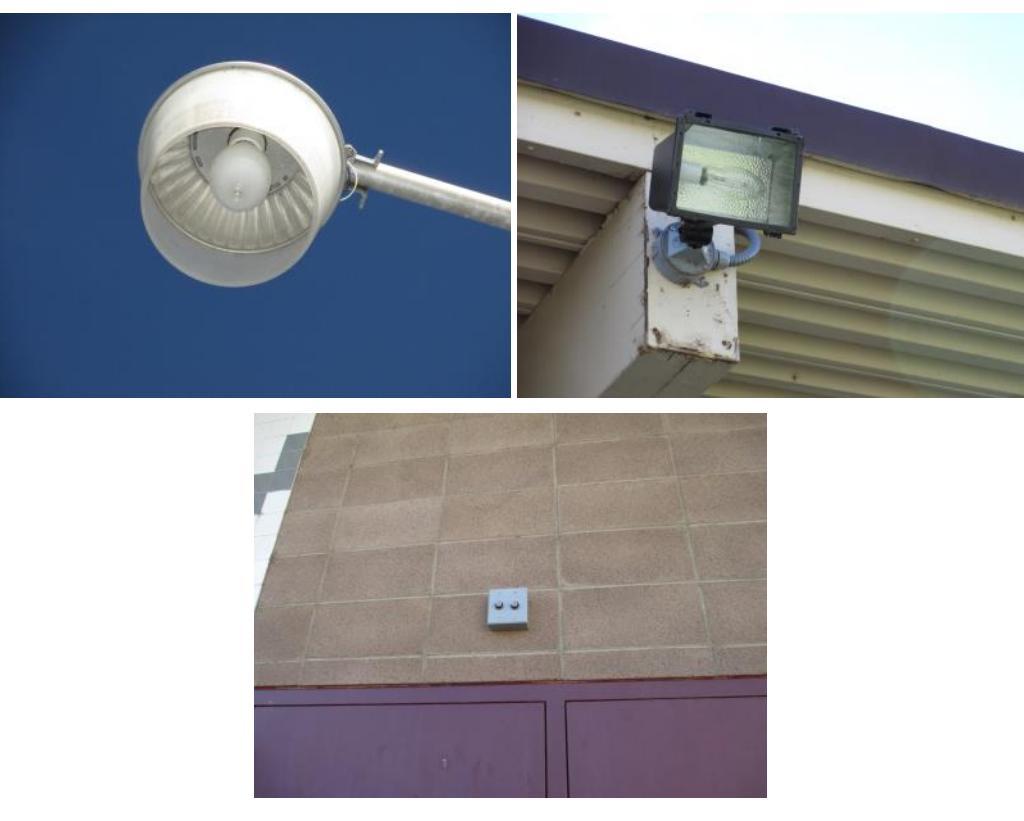
There are several high pressure sodium fixtures around the school that provide security lighting at night. The exterior fixtures are controlled by photocells.

Figure 16: HPS Security Light Fixtures (Top) and Photocell (Bottom)

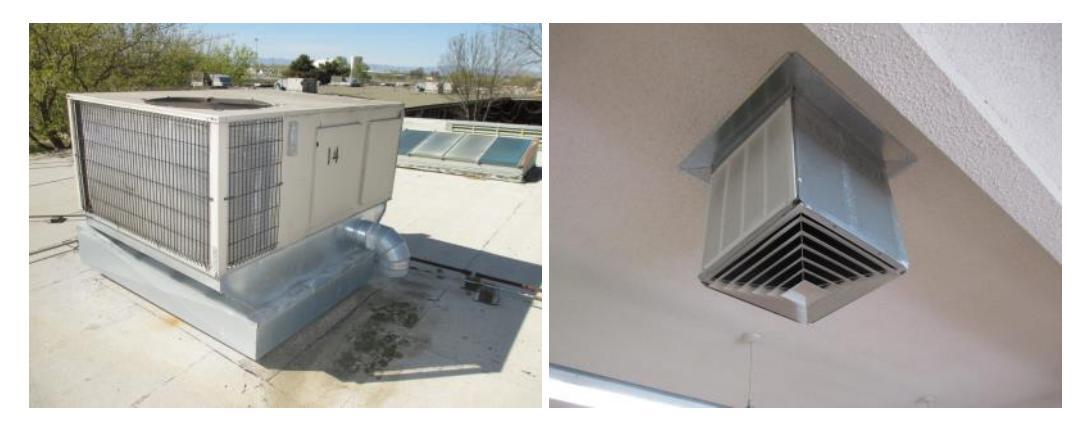
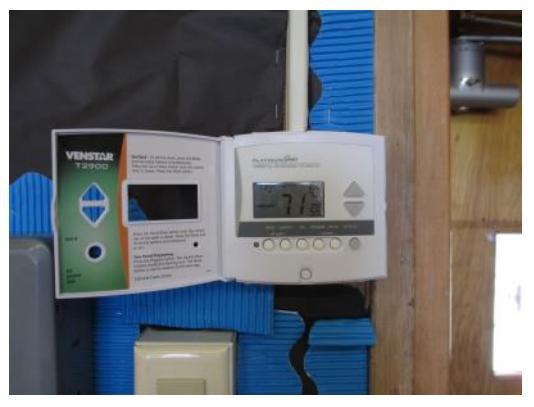
The permanent classrooms are mainly served by single zone rooftop units and are controlled by digital thermostats. The supply and return ducts share the same plenum and the supply and return diffusers are positioned next to each other. This causes some of the supply air to flow directly into the return air duct before having a chance to circulate through the room; this is also known as short circuiting. It was also noticed that a door to one classroom was open to the exterior while the RTU was running; this classroom did not have a thermostat.

Figure 17. Packaged RTU (Top Left), Supply and Return Ducts on Common Shaft (Top Right), Digital Thermostat (Bottom)

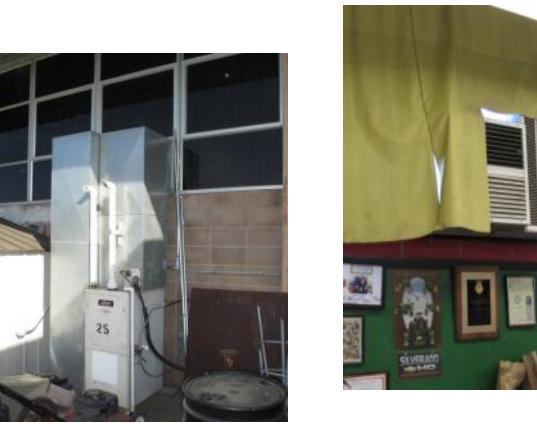
There are some classrooms that use packaged gas furnace/air conditioning units. It was noted that the supply and return air diffusers for these units were close together and may also experience air flow short circuiting.

Figure 18. Packaged Gas Furnace/Air Conditioner (Left) and Supply and Return Air Diffusers (Right)

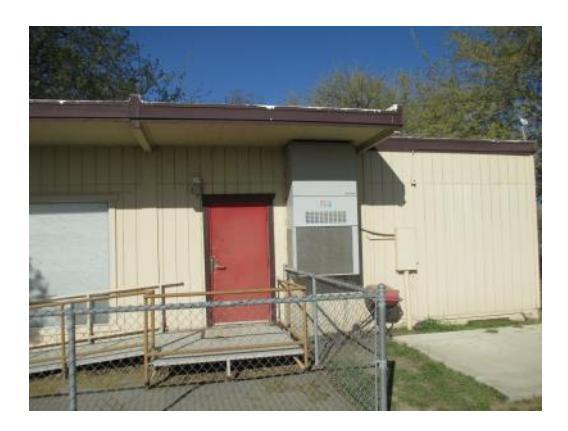
The portable buildings use either gas packs or heat pumps and are controlled by digital thermostats. The digital thermostats are set up with temperature setbacks of 55°F for heating and 85°F for cooling every day. The thermostats were not set up with daily schedules, so the units can operate during non-school days if thermostats are inadvertently left in the ON position. The thermostats are locked to prevent schedule changes, but staff has access to change the temperature setpoint.

Figure 19. Portable Building with Wall Mounted Heat Pump

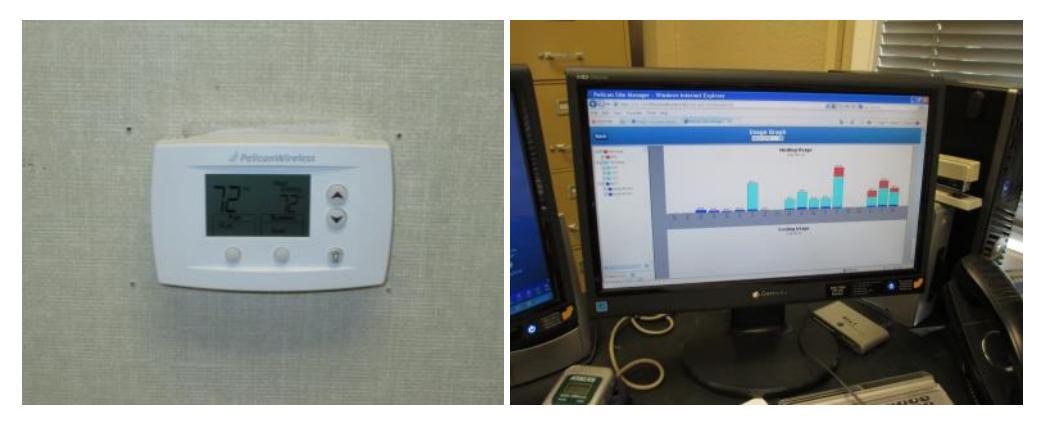
The school is in the process of upgrading the digital thermostats with wireless thermostats, which will give maintenance staff the ability to control the room temperature and operating schedule via a web browser from a web-enabled device. The wireless thermostats have been installed in six rooms to date.

Figure 20: Wireless Digital Thermostat (Left), Web-Enabled Wireless Thermostat Manager (Right)
